# 2021+ Front End PTO Belt Replacement Instructions

**Purpose:** To replace the front end PTO belts on the Butler System.

**Applicable Models:** 2021-present GMC & Chevrolet Cargo vans with 4.3L V6 & 6.6L V8 engines.

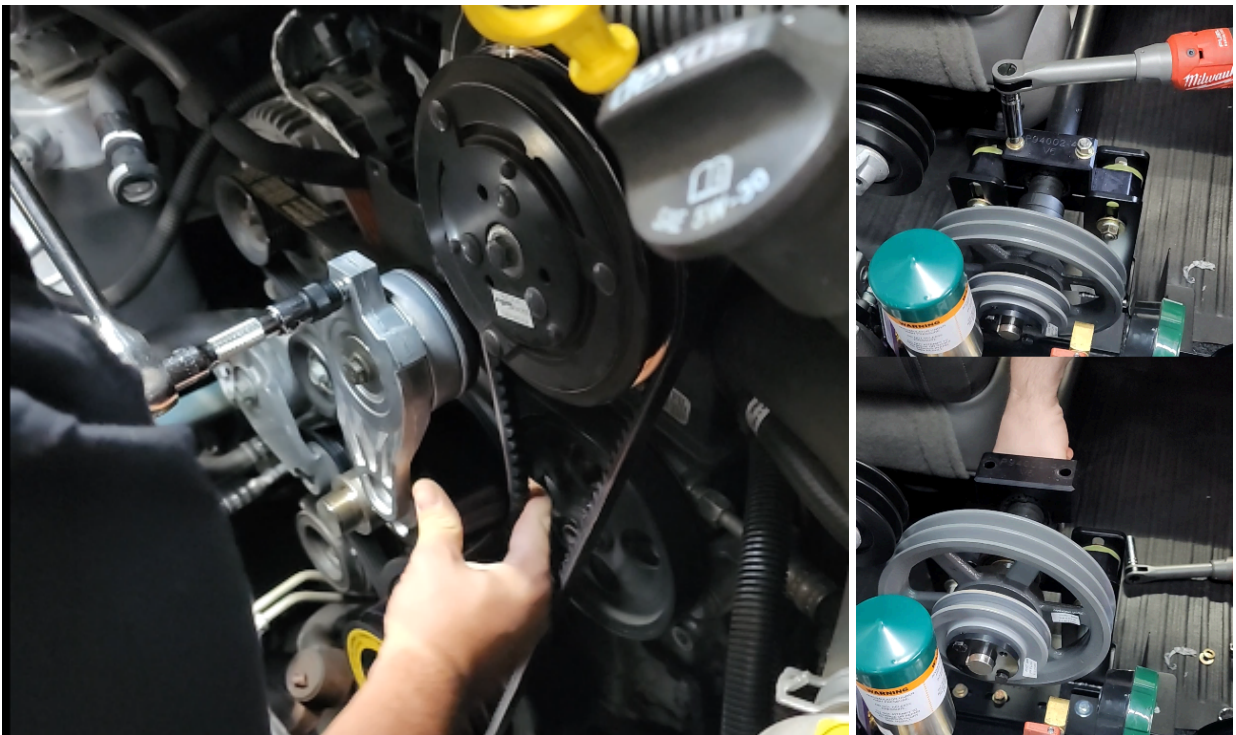
Cooling Fan removal is not required but removed for picture clarity.

12. Remove the old belts using a  $\frac{3}{8}$ " drive ratchet and extension to take the tension off.
13. Install the new belts. **If the belts are too tight to install, follow steps 13a-13i.**

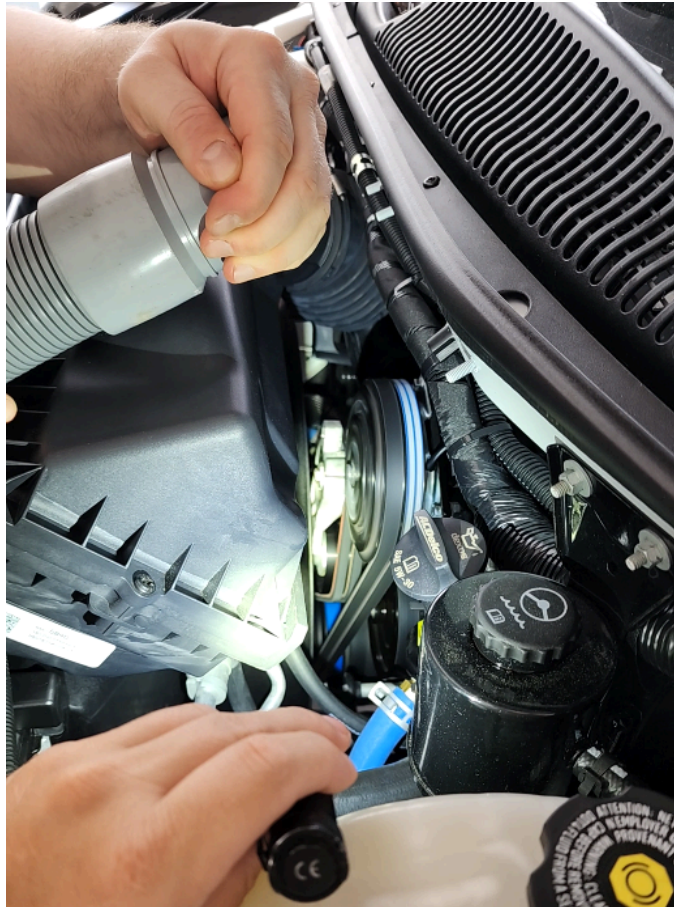
**Start the van's engine and visually inspect the belts to see if the belts are riding correctly on the pulleys.**

**Run the Butler System at high speed and add a load to the Vacuum Hose while visually inspecting the belts to ensure they are riding correctly on the pulleys.**

**If the belts ride correctly on the pulleys, the belt replacement procedure is now complete and you can return the unit back to service.**
